# NEDRA CONSTRUCTION COMPANY

This project presents the planning, architectural layout, structural design, and cost estimation of the proposed building development. The study was carried out to apply civil engineering principles in a practical way and to develop a safe, functional, and economical structure. The project includes site analysis, foundation design, column design, beam design, slab design, staircase design, and preparation of drawings such as plans, sections, and elevations. In addition, geotechnical observations and site conditions were considered to ensure the suitability of the area for construction. Overall, the project demonstrates the importance of proper planning, structural analysis, and engineering design in achieving a durable and efficient building project.

# GEOTECHNICAL REPORT

# STRUCTURAL DESIGN

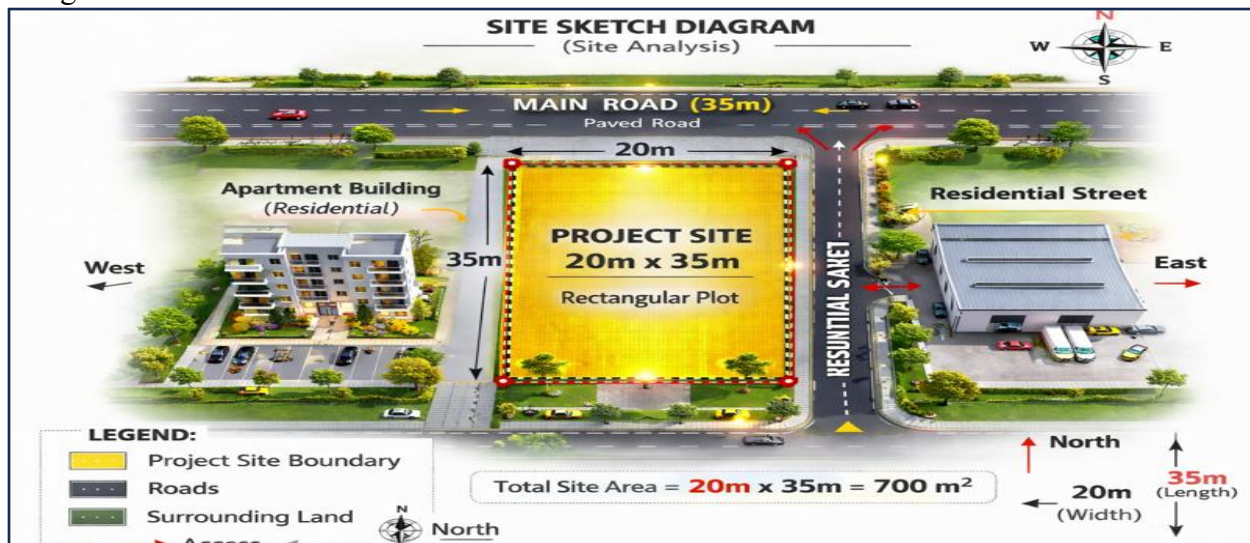
Located on the **north side**, connected to the **Main Road (35m)**. This is the primary entry point for vehicles and pedestrians

Located on the **east side**, connected to the **Residential Street**, providing access for service vehicles or secondary traffic.

Traffic flows are clearly indicated with arrows:

- Vehicles enter from the **Main Road (north)** and can circulate around the site.
- Vehicles can also enter via the **secondary/service entrance** on the **east side**.

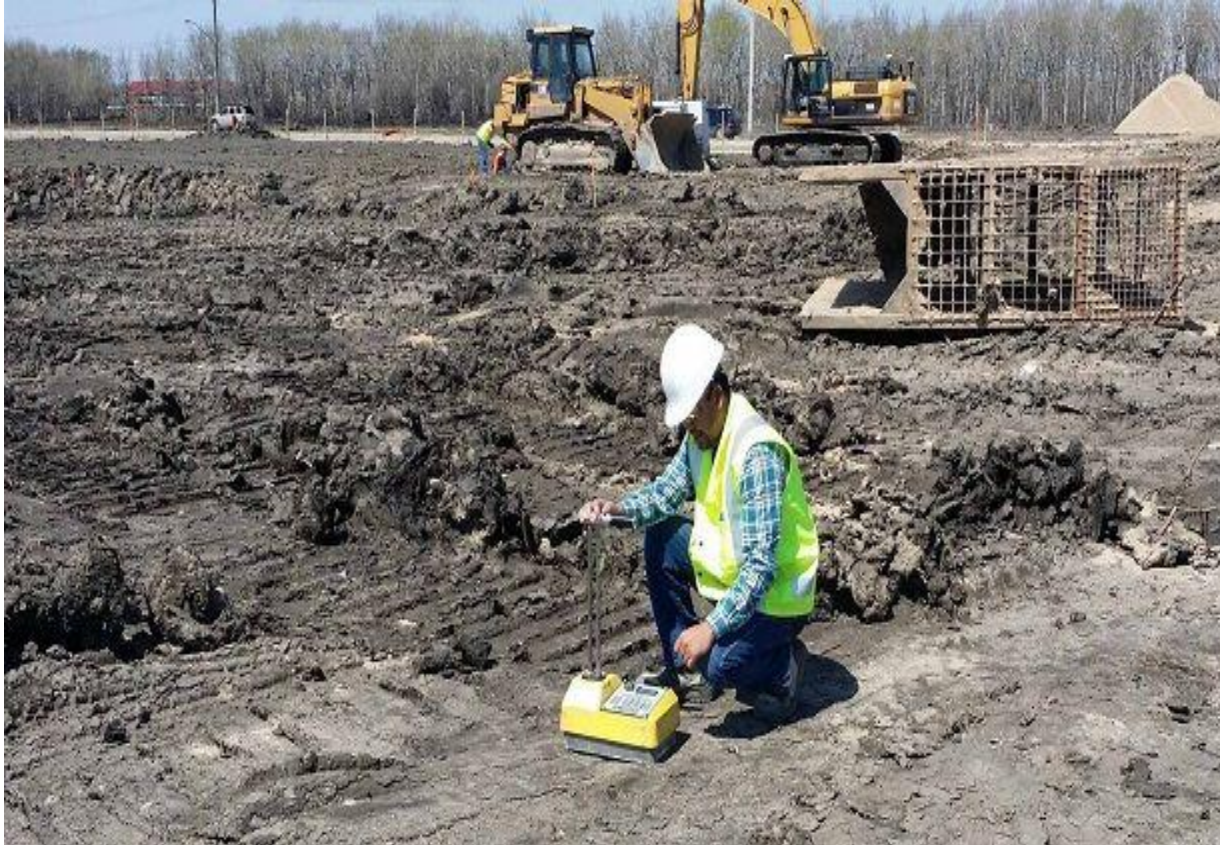
This report presents the findings of a preliminary geotechnical assessment conducted through visual observation only. The aim is to evaluate the general soil conditions and identify any potential geotechnical issues.

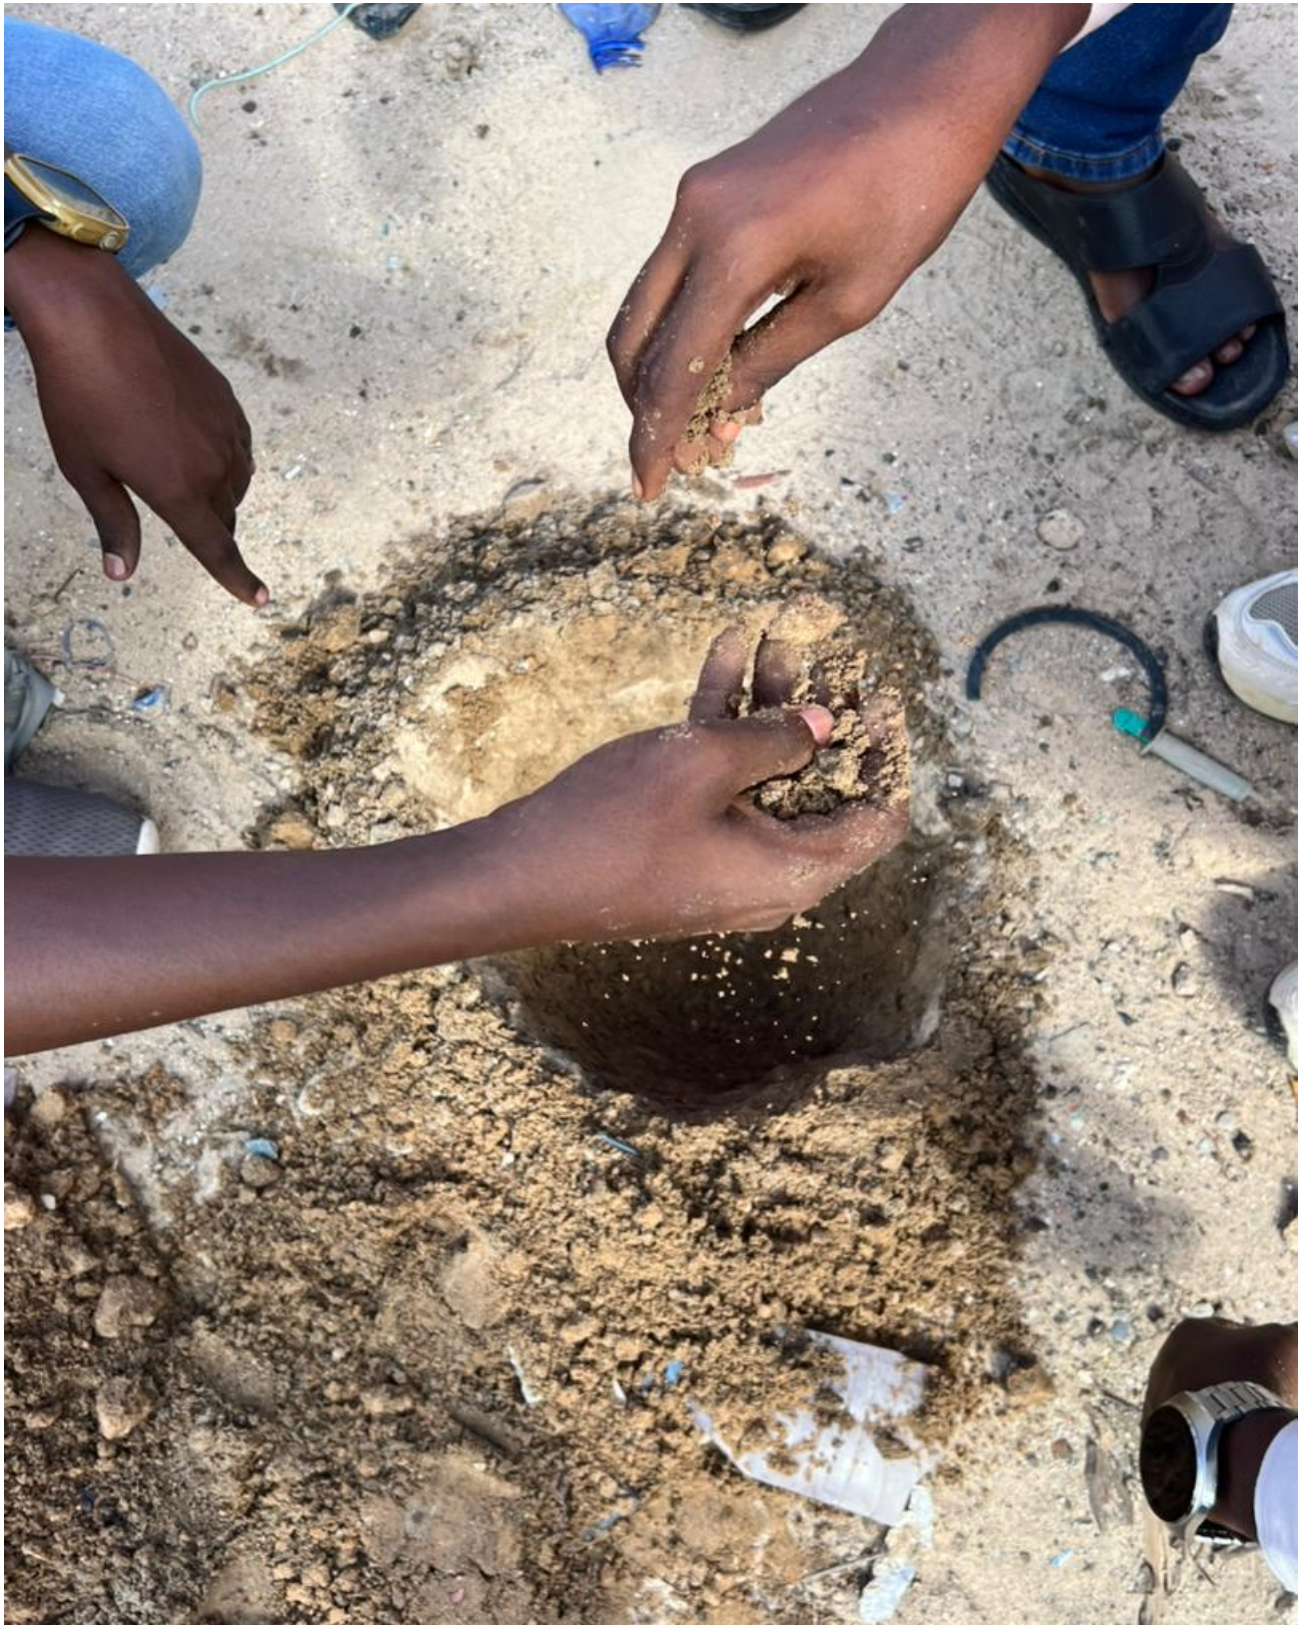
The site was assessed using visual inspection and manual hand-feel methods, without the use of any laboratory or field testing equipment. The investigation primarily focused on observing the surface characteristics of the soil and the general condition of the site.

Visual inspection included a detailed examination of the ground surface to identify soil color, texture, structure, and the presence of any visible features such as cracks, roots, debris, or signs of erosion. The slope of the terrain, drainage patterns, and surface stability were also carefully

observed.

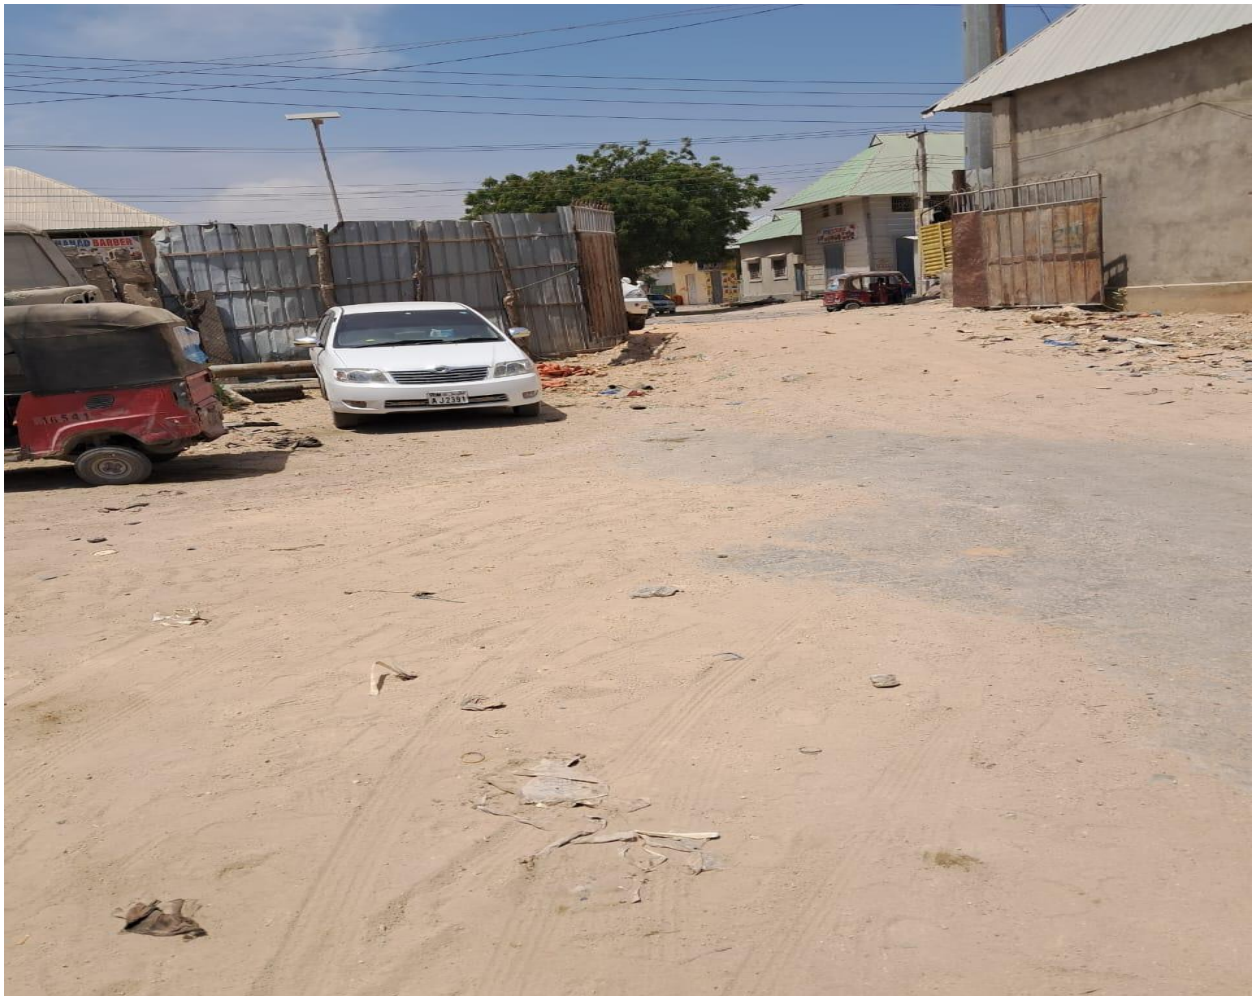
The ground surface is not entirely flat; it shows a gentle slope, with one side of the site being lower than the other. This slight variation in elevation may influence surface runoff and drainage patterns across the area.

The site is covered with predominantly dry soil and minimal vegetation. The soil appears relatively firm and moderately compact. A slight presence of moisture was observed within the soil, indicating limited water retention in the upper layer.

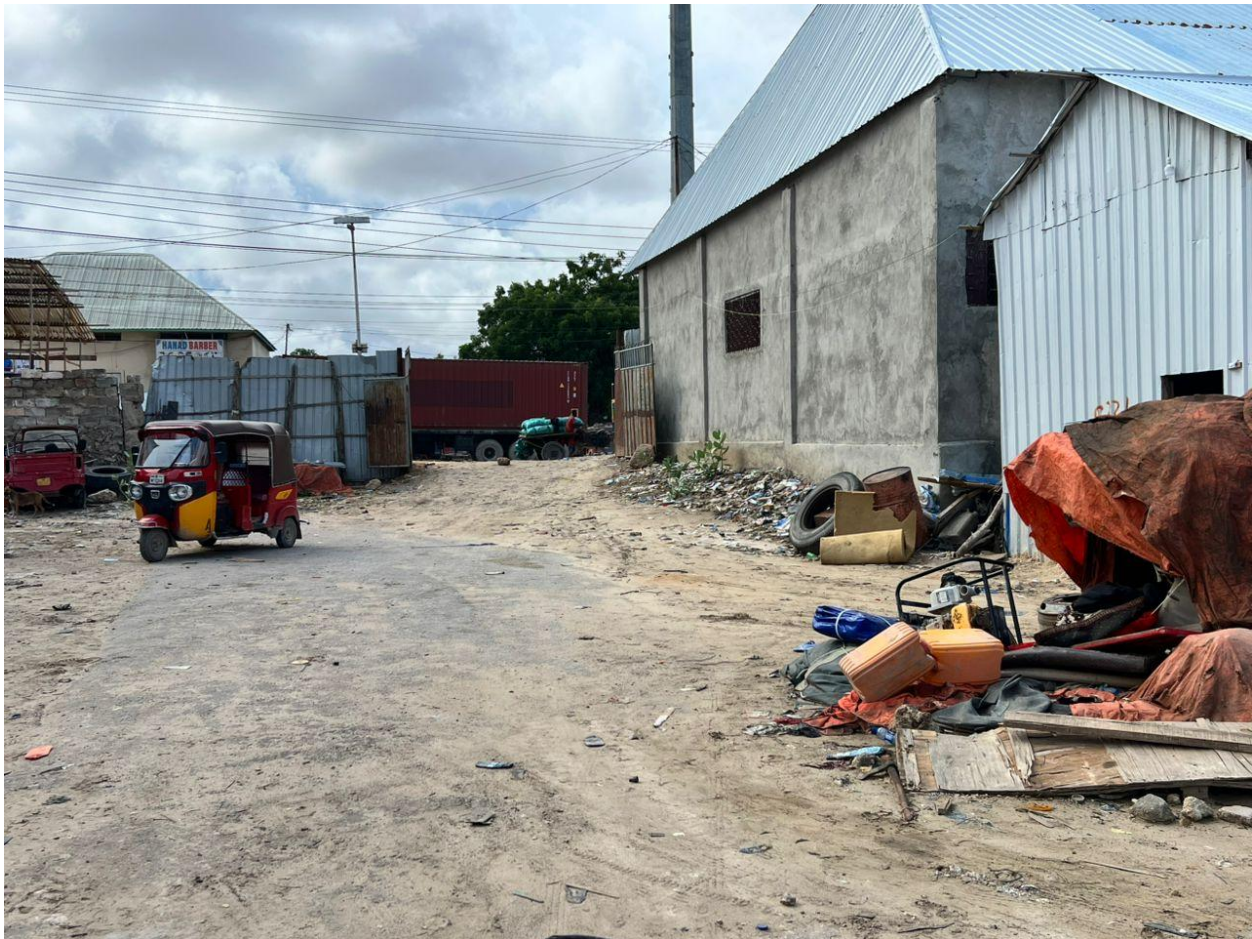
**Surface Conditions**

The soil observed at the site is brown in color and appears to consist predominantly of gravelly soil (coarse-grained material). The presence of gravel indicates relatively larger particle sizes, which may contribute to good drainage characteristics.

The soil is generally hard and well-compacted at the surface, suggesting a relatively dense condition. Due to its coarse nature, the soil exhibits low plasticity and limited cohesion when assessed using the hand.

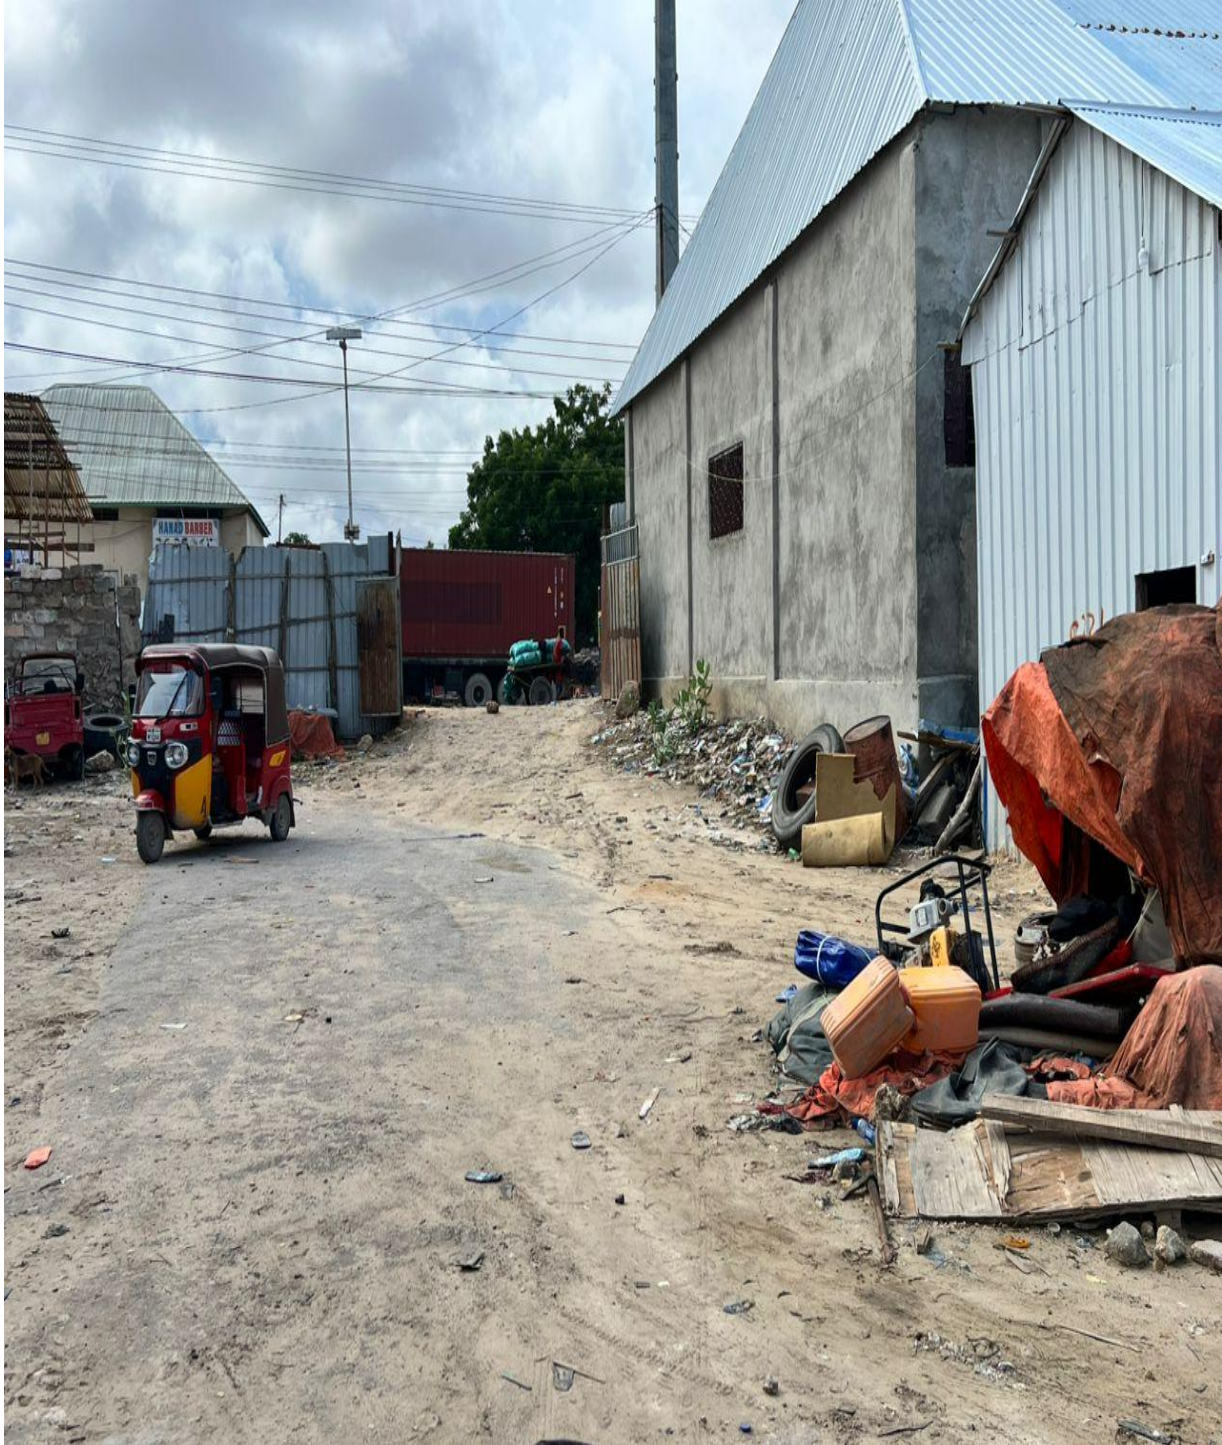
No groundwater was observed at the surface durin the site visit.

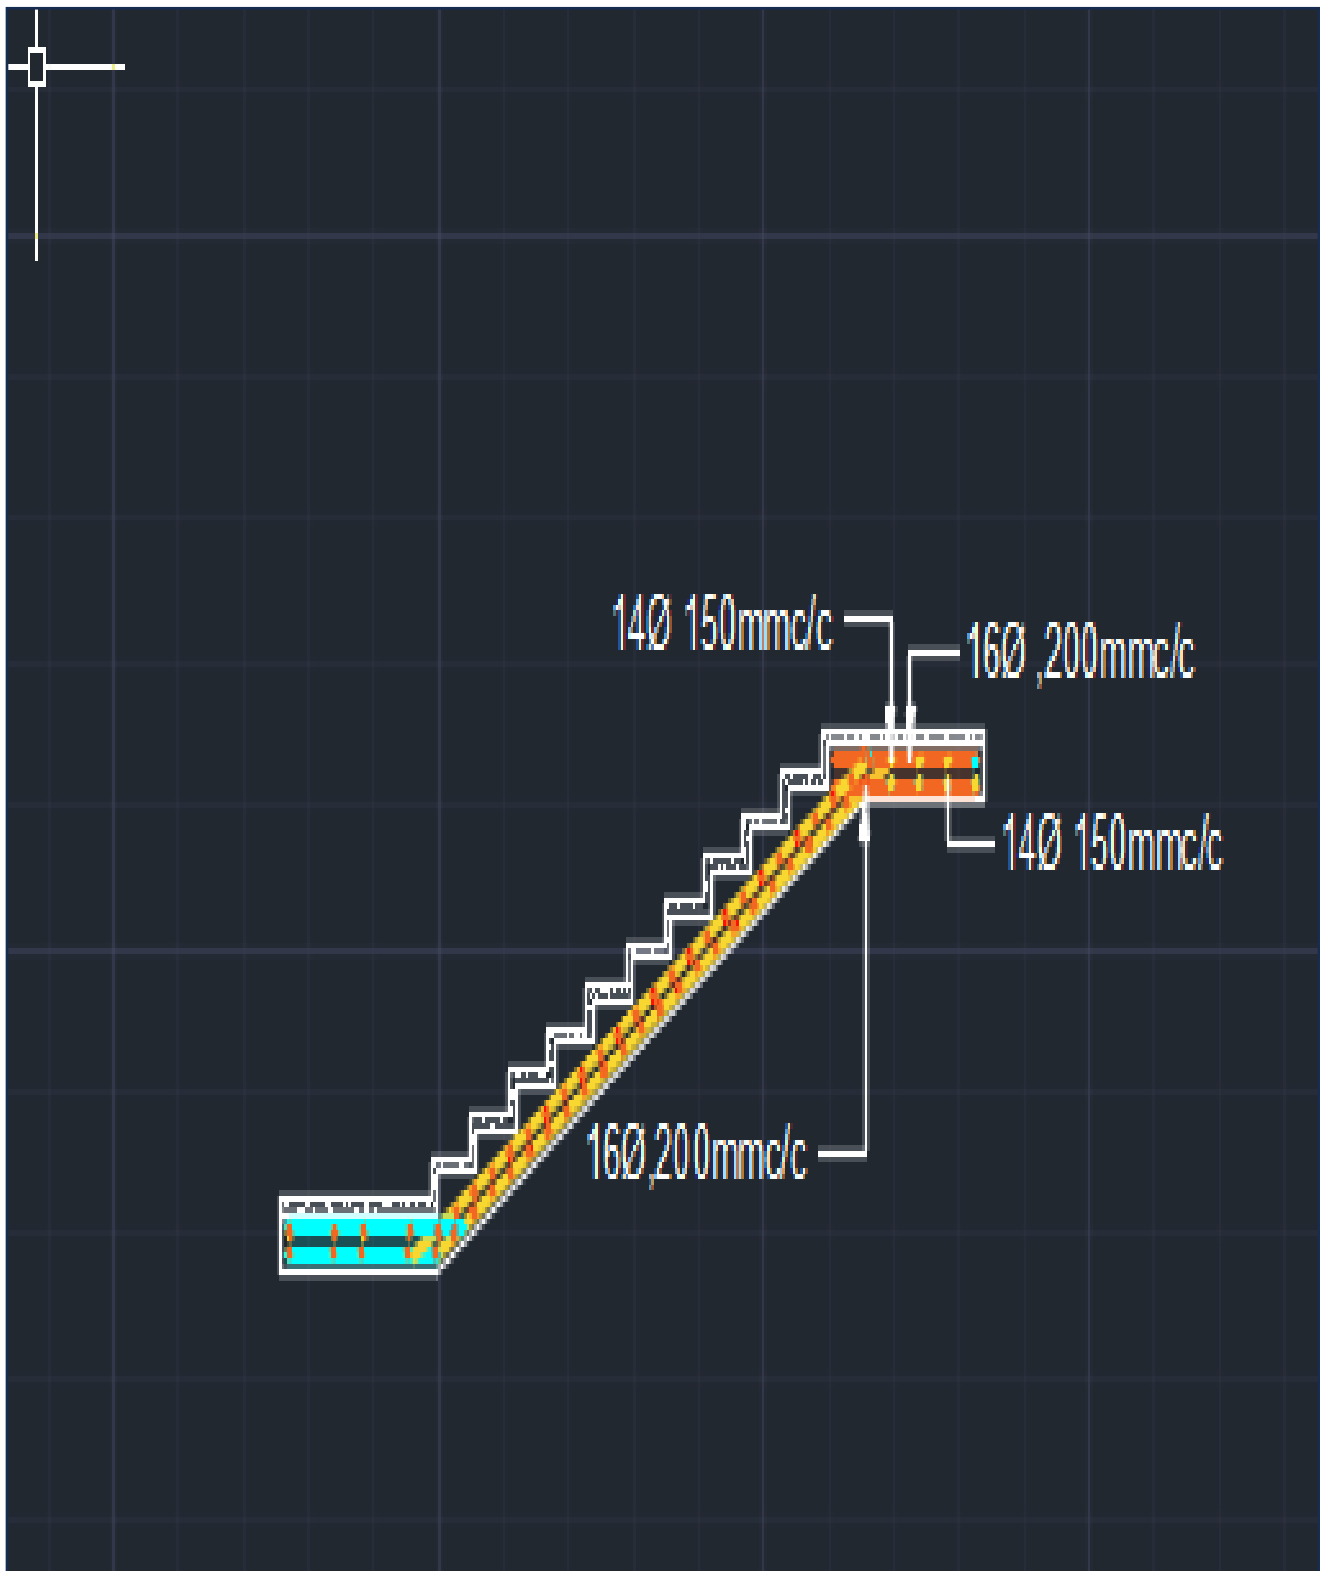
**Staircase Design** is the process of planning and designing stairs to provide safe, comfortable, and efficient movement between different floor levels.
